ACCIDENTAL RADIATION EXCURSION AT THE OAK RIDGE Y-12 PLANT—II

HEALTH PHYSICS ASPECTS OF THE ACCIDENT*

J. D. McLENDON

Union Carbide Nuclear Co. Y-12 Plant
Oak Ridge, Tennessee†

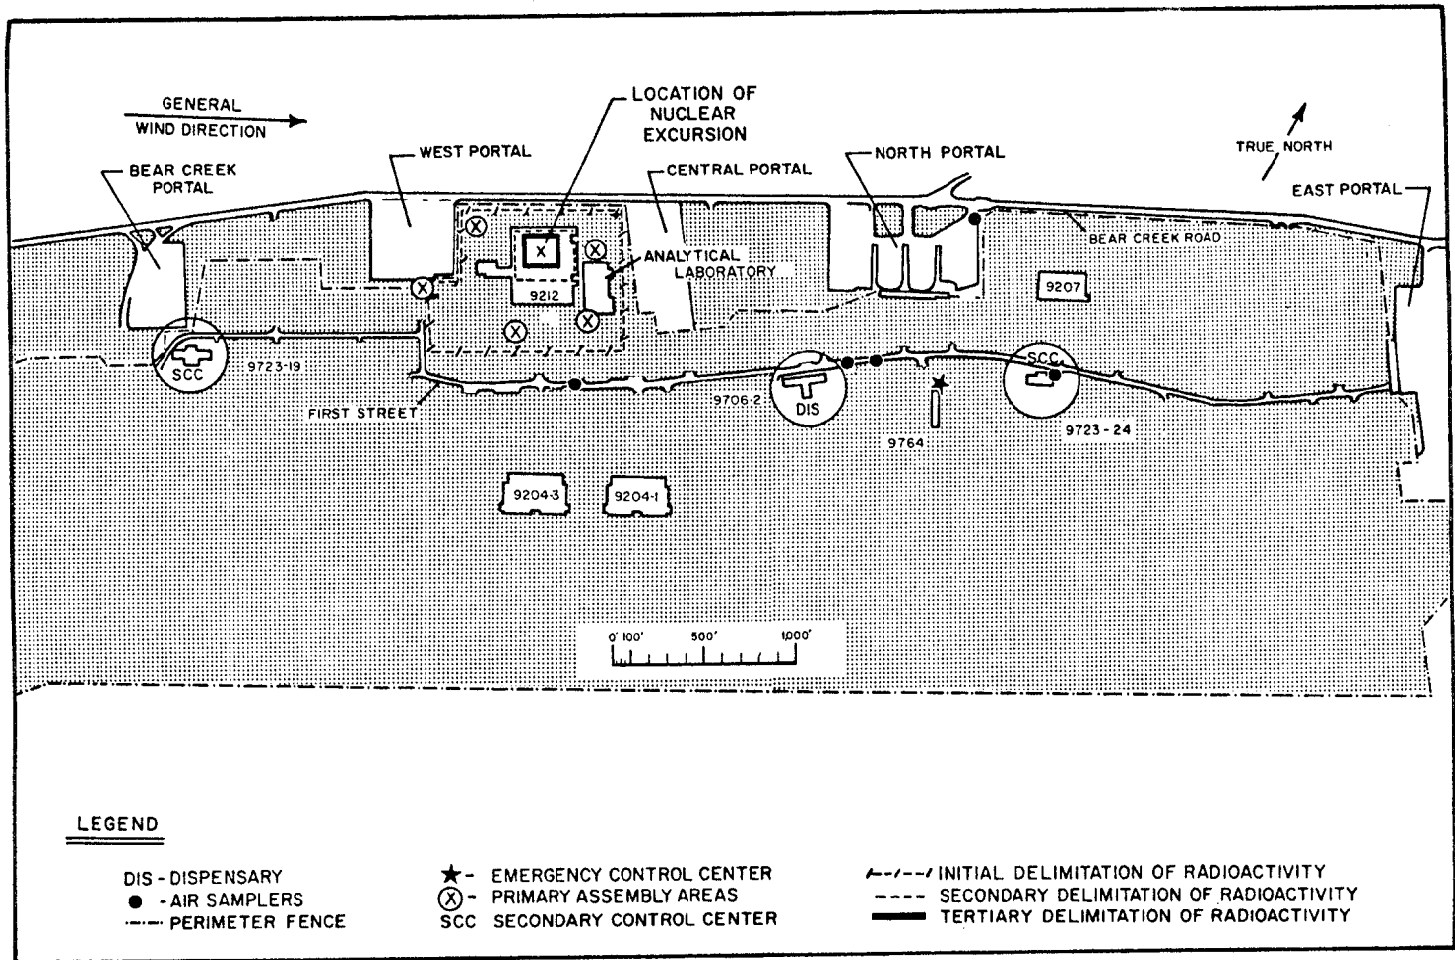
Fig. 1. Location of Y-12 Plant buildings pertinent to incident.

sounded the alarm in Building 9212, implementing the building evacuation plan. Immediately, process supervisors, equipped with emergency radiation survey meters detected, and confirmed by multiple readings, radiation intensities of more than 100 mr/hr at the building control center, a distance shown later to be about 350 ft from the location of the accident. The Plant Emergency Director, who was present at the time of the alarm, acted to put the plant emergency plan into effect, thus evacuation of personnel from primary assembly points to secondary control centers proceeded with little further delay (see Figs. 1 and 2 for locations).

Radiation surveys were made of the plant area to obtain an overall evaluation of conditions. Within an hour after the incident, it was determined that there was no direct radiation or significant contamination outside the perimeter fencing, which forms the security area in which Building 9212 is located. This area, approximately 800 ft \times 1000 ft, was subsequently marked off as the initial delimitation area.

Within $1\frac{1}{2}$ hr after the excursion, teams of health physicists began approximating the site of the incident by a series of perimeter radiation surveys. The radiation and contamination levels encountered were quite low, ranging from 0.2 mr/hr at the boundary of the primary delimitation arc to 10 mr/hr at distances of approximately 200 ft from the drum. Although some spillage of materials had occurred in a few areas due to unattended operating equipment, no serious contamination levels were encountered. Boundary limits were adjusted to permit employes to re-enter all areas except those within the secondary delimitation boundary (≈ 350 ft \times 400 ft) shown in Fig. 1.

concentrations of air-borne contamination still existed in the area. Radiation measurements, direct and by air-sampling, were continued in the zone proximate to the accident area. Within a few hours, it was possible to relax the restriction boundaries to that area indicated as the tertiary delimitation area in Fig. 1.

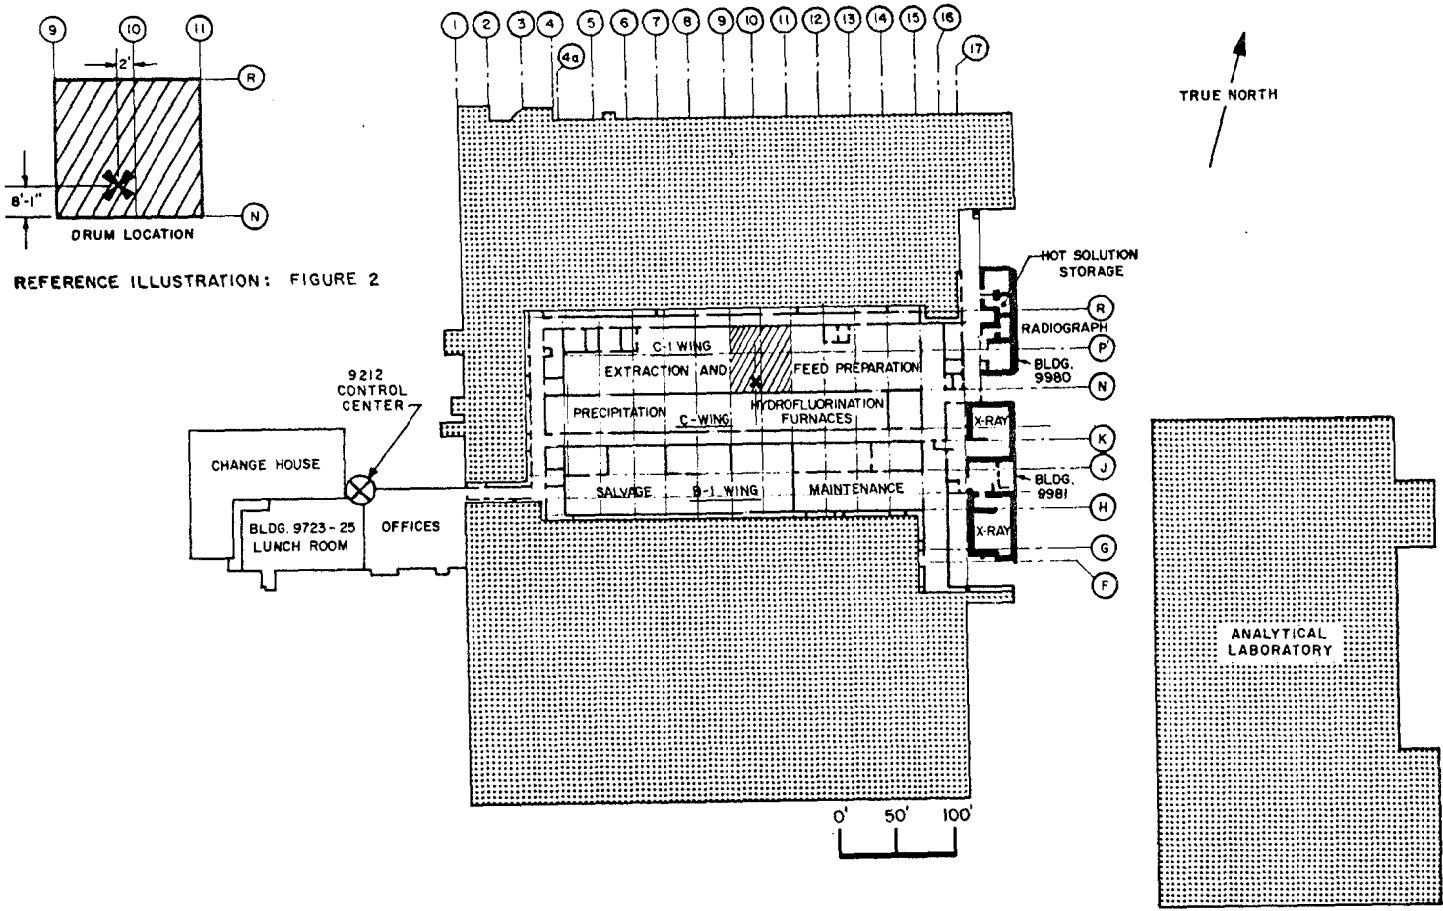
Fig. 2. Location of nuclear excursion, Building 9212.

Some 3 hr after the incident, an emergency team undertook a cursory survey of the salvage area in which the reaction had occurred. The radiation dose rate itself at the southwest door of this area, a distance of approximately 100 ft from the drum, was 60 mr/hr. When the men emerged, after being in this location for about 10 min, the cannisters of their gas masks read from 10 to 15 mr/hr, indicating that significant

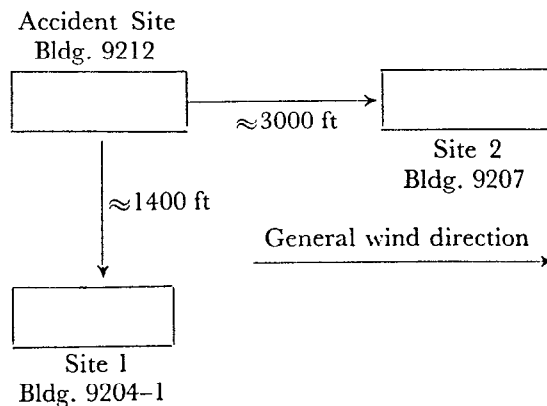
Some indication of air-borne contamination released to the atmosphere may be obtained from inspection of two continuously recording β - γ air monitors which were located as shown in the sketch below. These monitors are Geiger-Muller tube instruments measuring and recording the β - γ emission from particulates collected from an air stream on a fixed filter paper. The tubes are surrounded by the filter and are shielded by $1\frac{1}{2}$ in. of lead.

Both instruments detected the initial direct gamma radiation from the actual excursion and both showed subsequent increases in the level of atmospheric beta-gamma contamination. The

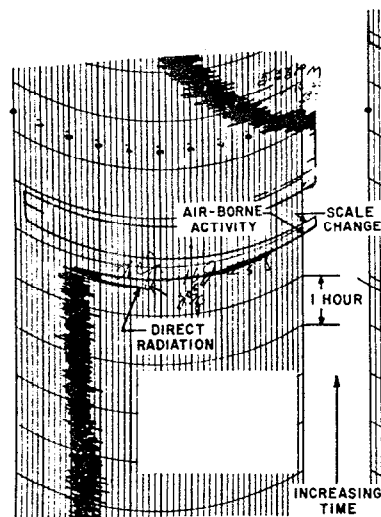
FIG. 3. Monitor chart, Building 9207 (site 2).

following observations are made from inspection of the charts from these instruments (see Figs. 3 and 4).

- (1) The level of initial direct radiation recorded at site 1 was higher than that observed at site 2 because of the distances involved.
- (2) The air-borne contamination, however, reached site 2 much sooner (10 min vs. ≈ 45 min) and in higher concentrations (considerably more than a factor of 3), since it was directly downwind.
- (3) Because of the short half-lives of many of the fission products (< 2 hr) and the relatively short length of exposure of any persons to the contaminated atmosphere, the concentrations detected constituted no acute hazard.
- (4) Considering the favorable conditions of wind velocity and direction existing at the time and the levels of concentration detected, it can be stated, with a high degree of confidence, that no significant concentrations of these activities reached any nearby populated areas.
